TECHNICAL SERVICE BULLETIN

All Wheel Drive (AWD) - Right Side Transfer Case Fluid Leak

18-2255
22 August
2018

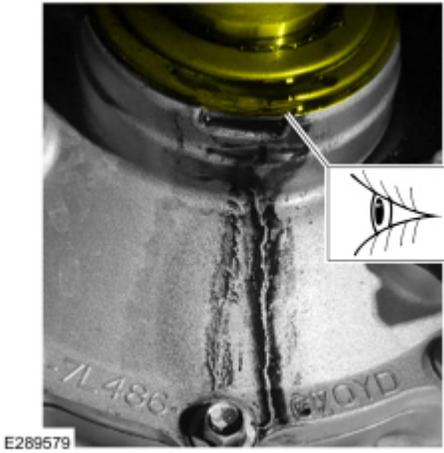
Figure 1

Issue: Some 2013-2018 Escape vehicles equipped with 1.5L/1.6L/2.0L EcoBoost, 2013-2018 Fusion vehicles equipped with 2.0L/2.7L EcoBoost, 2013-2018 MKZ vehicles equipped with 2.0L EcoBoost, 2017-18 MKZ vehicles equipped with 3.0L EcoBoost, 2015-2018 MKC vehicles equipped with 2.0L/2.3L EcoBoost, 2015-2018 Edge vehicles equipped with 2.0L/2.7L EcoBoost, 2016-2018 MKX vehicles equipped with 2.0L and 2.7L EcoBoost, 2016-2018 Explorer vehicles equipped with 2.3L EcoBoost, 2017-2018 Continental vehicles equipped with 2.7L/3.0L EcoBoost and 2016-2018 Focus RS equipped with 2.3L EcoBoost may exhibit a dark black fluid leak from the right side transfer case intermediate shaft seal.

- Inspect the intermediate shaft seal for leakage. Is the intermediate shaft seal leaking? (Figure 1)
 - Yes - replace the intermediate shaft seal. Refer to Workshop Manual (WSM), Section 308-07. It is not necessary to remove the power transfer unit (PTU) to replace the seal.
 - No - this article does not apply. Refer to WSM, Section 308-07 for normal diagnostics.
